MAX-OUT YOUR MINI

Installing Wilwood four-wheel disc brakes on a 2007 Mini

The brake upgrade we are making is on a MKII R56 model and it will feature a Wilwood part number 140-8528-DC kit that features Wilwood red DynaPro four-piston radial mount calipers and 12.19-inch rotors. The rotors and calipers are designed with race proven technology and will not only slow the Mini down faster than the stock brakes, they are also lighter and that will improve handling. The rear of the Mini was also improved with a Wilwood part number 140-10885-DR kit that uses the Combination Parking Brake Caliper, a hydro-mechanical parking brake caliper that utilizes hydraulic pressure from the master cylinder for stopping power and an internal mechanical lock for the parking brake. The rear calipers are coupled with 11.75-inch rotors to provide balanced brake performance for the street or the occasional track day with the added benefit of a 7-pound weight reduction.

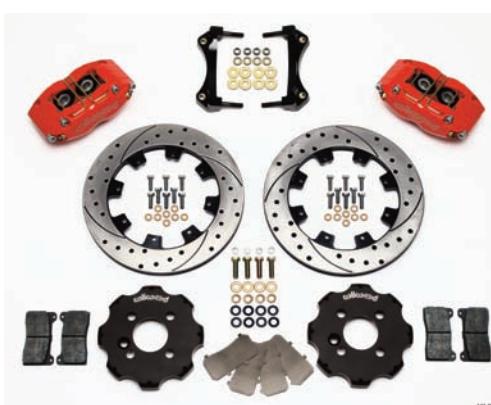
The Wilwood part number 140-8528 front disc brake kit comes complete with the rotors, hats, DynaPro calipers, pads, caliper brackets and all of the hardware required to finish the installation. The kit ordered features red calipers and the slotted and cross-drilled rotors.

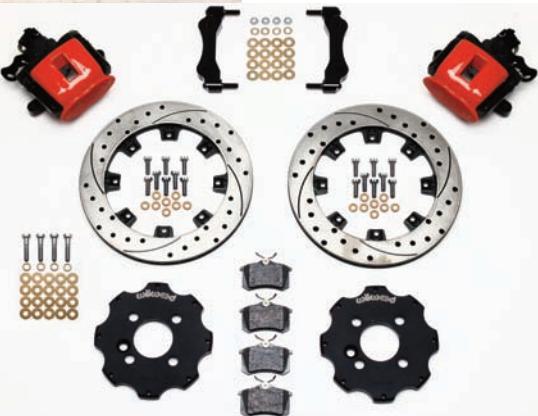
The Wilwood part number 140-10885 rear disc brake kit comes complete with the rotors, hats, Combination Parking Brake (CPB) calipers, pads, caliper brackets and all of the hardware required to finish the installation. The kit ordered features red calipers and cross-drilled rotors.

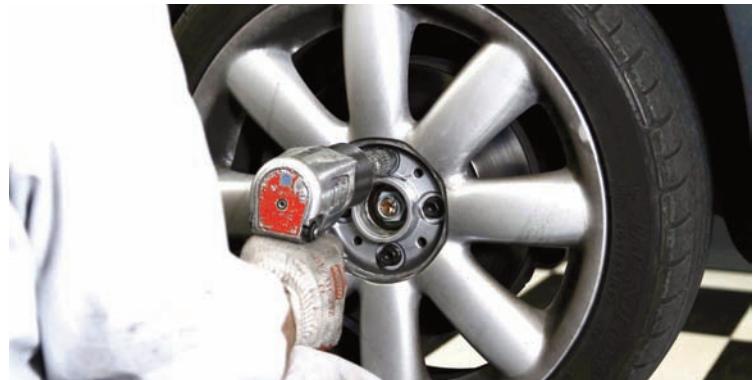
Using a floor jack, the front of the Mini was raised and was placed on jack stands. The hubcaps were removed to access the lug bolts. Using the proper size socket and an impact gun the lug bolts were disconnected and the wheels and tires were removed.

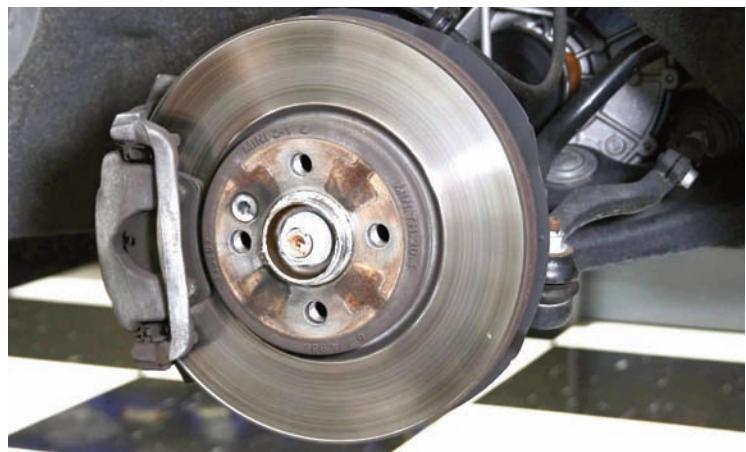
After the wheels and tires were removed, you can see the original Mini brakes and rotors. This car uses lug bolts instead of lug nuts and the rotor is secured to the hub with a large torx bolt.

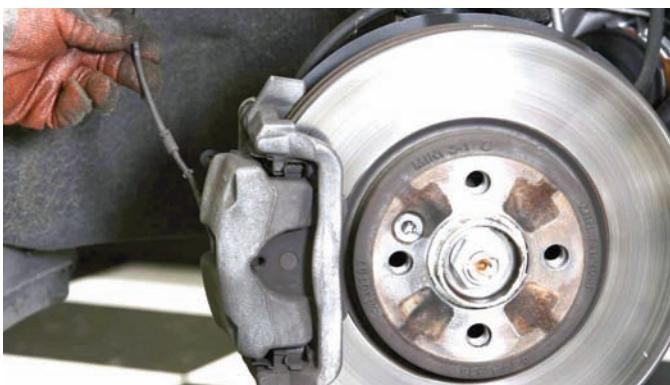
The original flexible brake line was disconnected from the steel hard line in preparation of removing the caliper. There is a rubber grommet on each flex line so it was removed and retained for reinstallation on the new Wilwood Flexline.

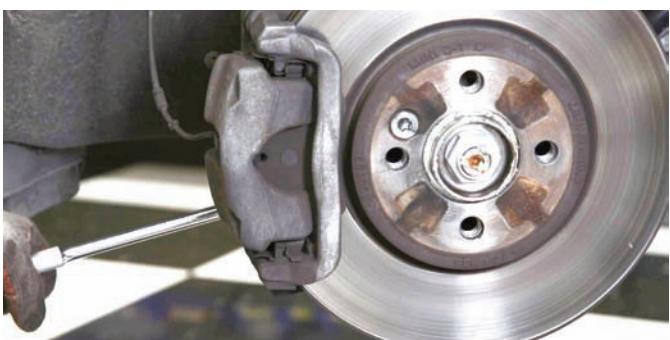
Using a breaker bar and the correct size socket, the caliper bolts were disconnected from the front hub assembly.

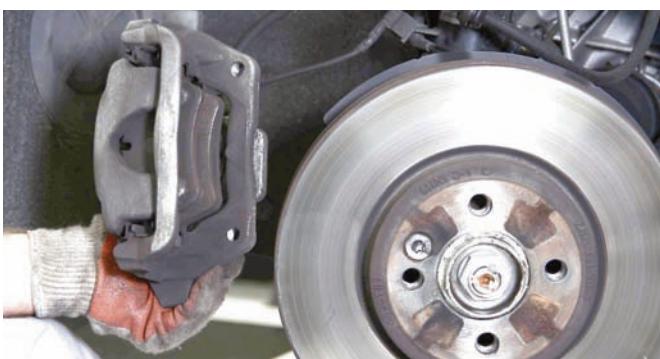
After the bolts were disconnected, the cast iron caliper was removed from the brake assembly. The new brake caliper is much lighter than the old caliper.

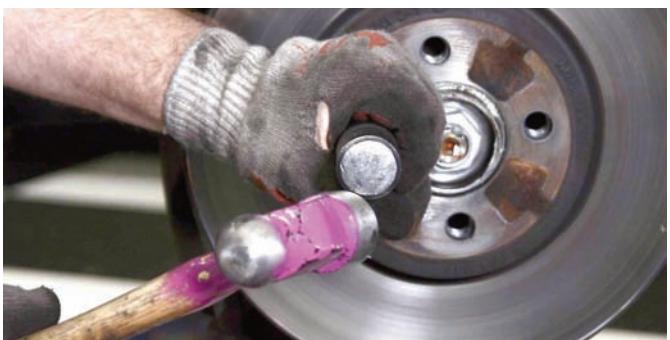
The torx bolt that secures the rotor to the hub was very tight, so it was loosened with an impact screwdriver. The bolts were retained because they will be used to fasten the new rotors.

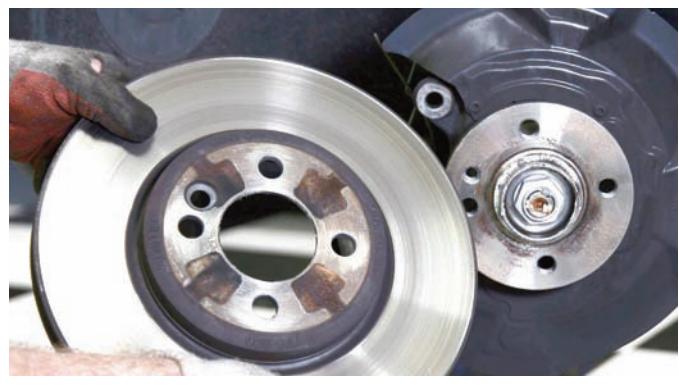
The rotor was tapped with a rubber mallet on the back-side to break it loose from the hub assembly. When it was loose, it was removed from the assembly.

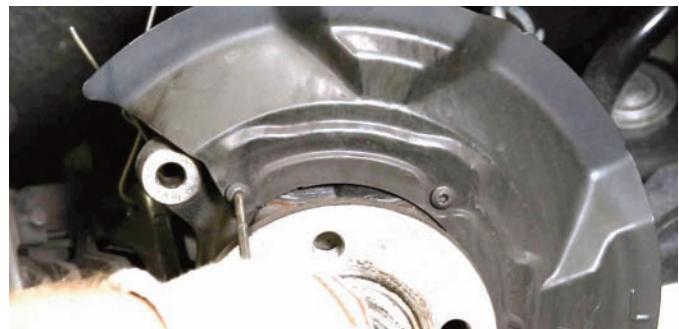
Using a torx screwdriver, the small screws that fasten the dust shield to the hub assembly were removed.

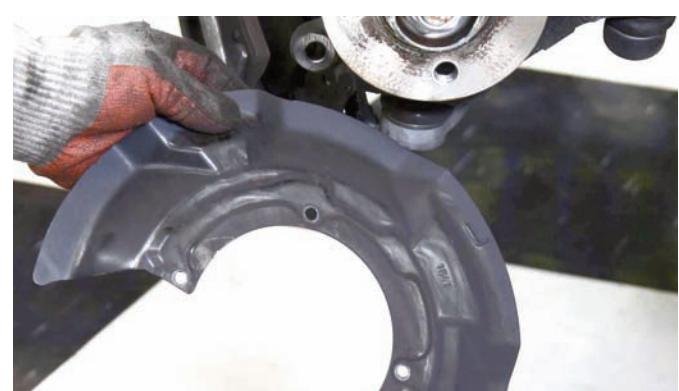
The dust shields were discarded because they will not be used with the new brakes.

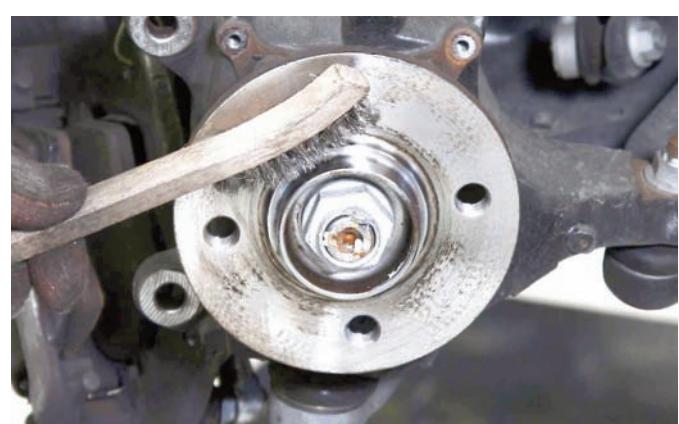
Before going any further, a wire brush was used to clean the grease and grime away from the hub locator on the hub.

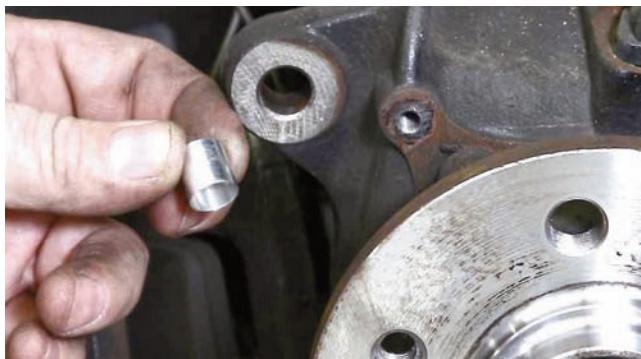
The original caliper mounting holes are rather large, so bushings are used in the top and bottom hole to downsize the holes.

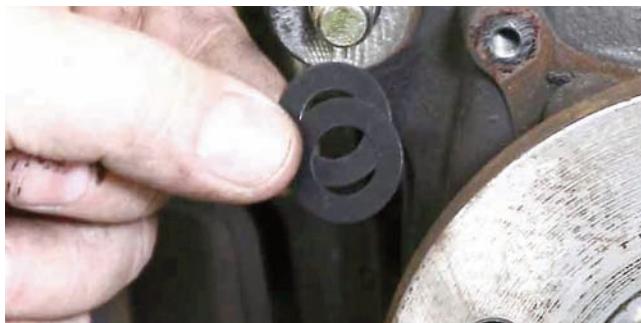
The bolts were installed into the original caliper mounting holes and two shims were installed.

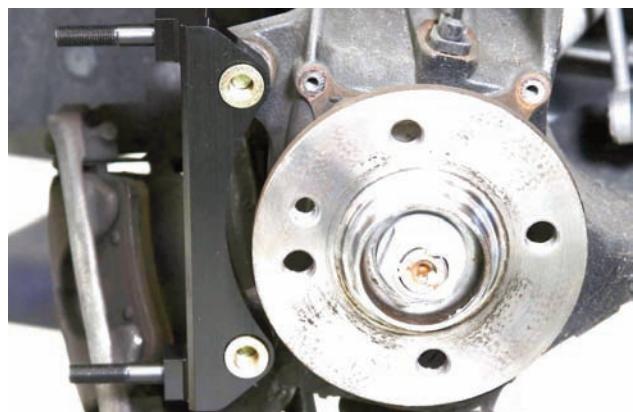
The caliper bracket was connected to the original mounting holes with the bolts supplied in the kit.

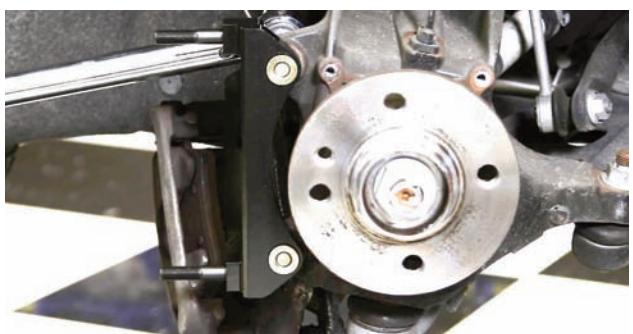
The bracket should be tight to check the rotor to caliper centering. It should be centered but if it is not, shims can be added or subtracted to get it perfect. After the centering was perfect the bracket bolts were coated with Loctite 271 and then they were tightened to 75 ft-lbs.

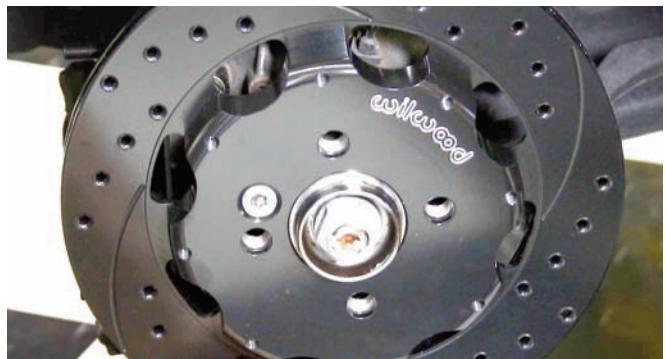
The rotor was installed on the hub assembly and the holes were aligned so that the mounting bolt could be installed and tightened.

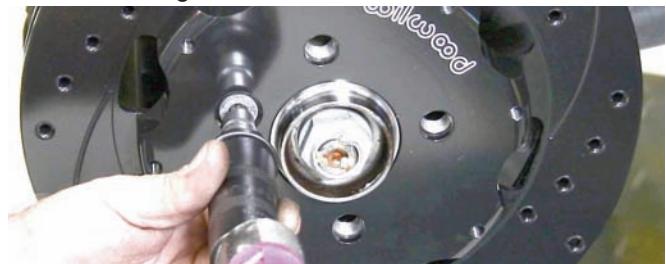
The rotor was attached to the hub assembly using the same torx bolt that fastened the original rotor. The impact screwdriver is reversible so a few whacks of the hammer got the bolt very tight.

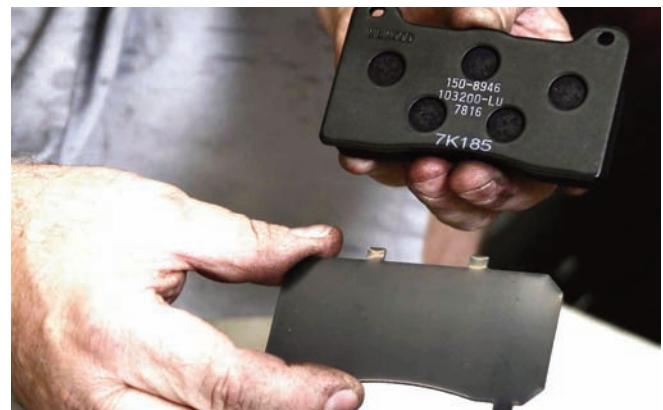
The adhesive backing was removed from the anti-squeal plate and then it was attached to the rear side of the brake pad. The tabs were bent over the pad baking plate to keep them in place.

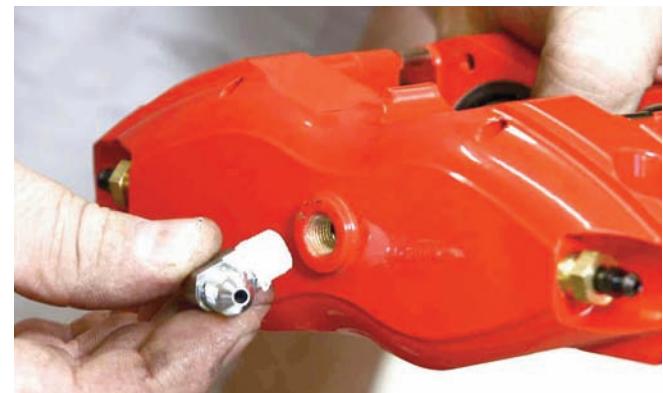
The inlet fitting was coated with Teflon tape and then it was screwed into the caliper. The fitting should be pointing upward.

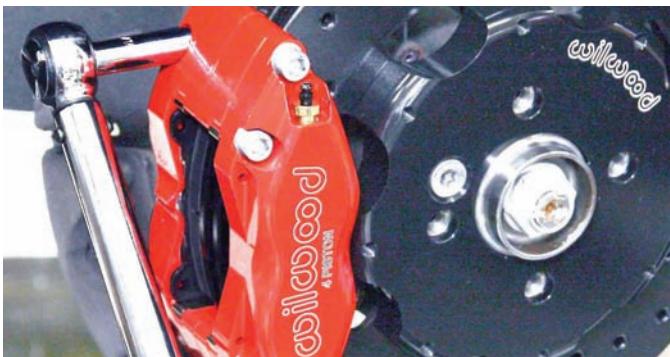
The caliper was placed on the caliper bracket and then the washers and locknuts were installed. Make sure the rotor is centered in the caliper, and when it is, the studs were lightly oiled and the mounting nuts were tightened to 30 ft-lbs using a torque wrench.

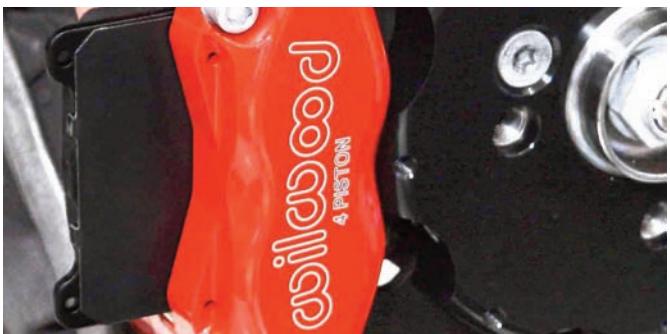
After the caliper was centered, the pads were installed from the top of the caliper. The pads were fastened with the Quick-clip pad retainer.

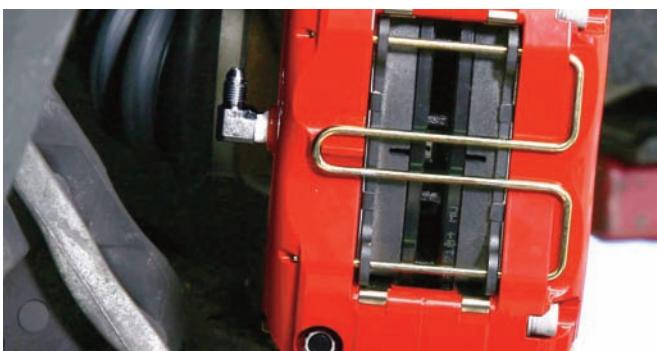
Here is a close look at the Quick-clip pad retainer that makes pad changes easy. Here you can also see that the rotor is centered between the pads.

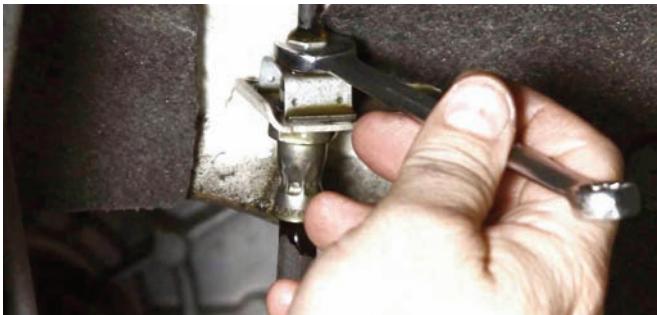
The old brake hose was removed and the new Wilwood part number 220-8491 was installed remembering to install the rubber grommet that were removed from the original hose. The hole in the bracket will have to be enlarged to hold the fitting used to adapt the Wilwood Flexline to the original steel line.

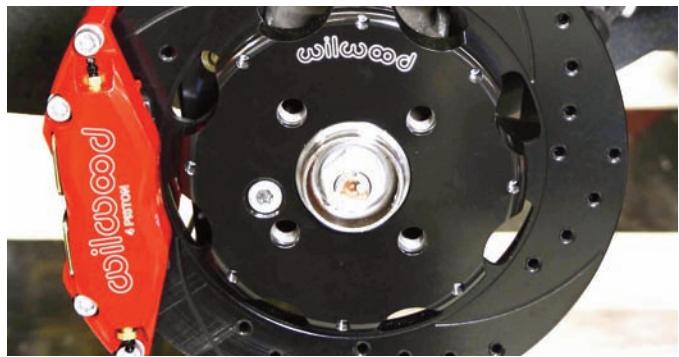
The finished brake assembly is looking good with the bright red caliper and black E-coated rotor. This system will improve the Mini braking, plus it looks nice doing it.

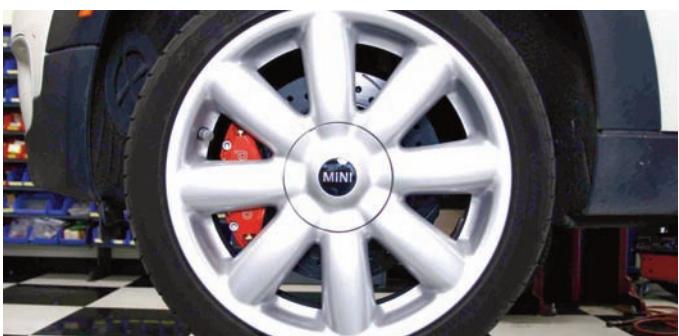
Here is the finished front brake assembly after the wheel was installed and was resting on the ground. The windows in the Mini wheels aren't real big, but you can still see the nice looking Wilwood brakes peeking through.

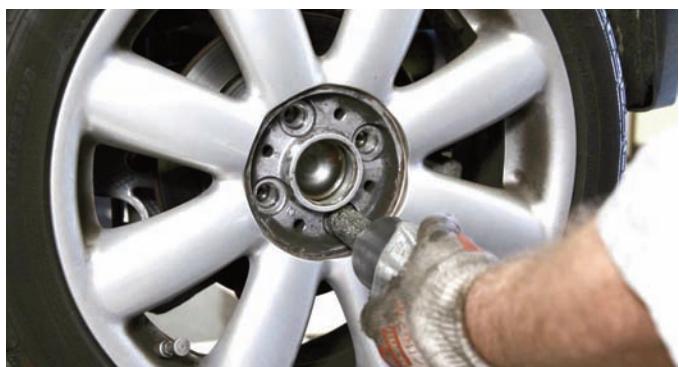
The rear of the Mini was raised and the jack stands were placed under the car for safety. The hubcaps were removed and then the lug bolts were disconnected with the correct size socket on an impact gun.

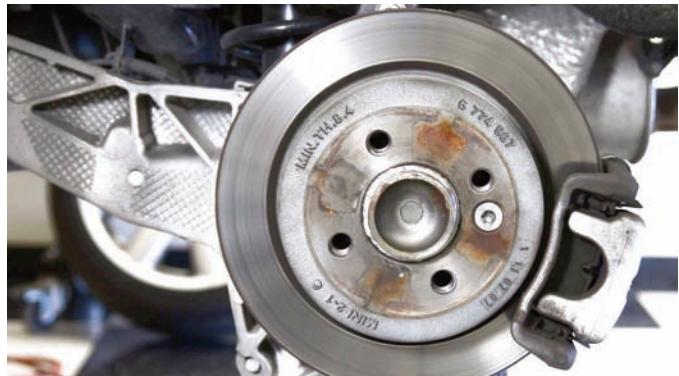
Here is a look at the factory disc brake setup that connects to a hub assembly that rides on a large aluminum lower control arm.

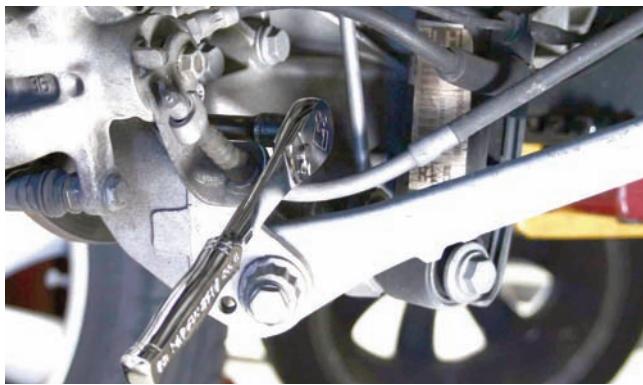
The bolts that fasten the caliper to the bracket were removed from the backside of the assembly as seen here.

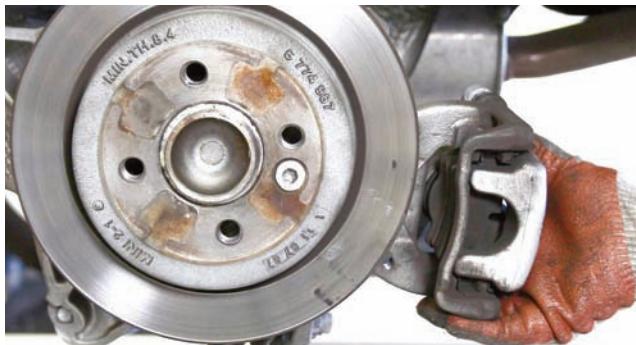
After the bolts were disconnected, the caliper was removed from the bracket and the car.

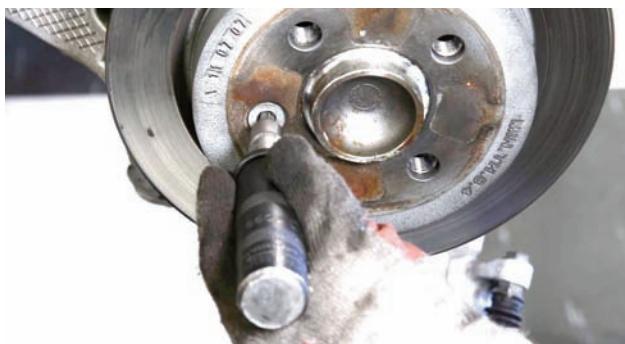
The torque bolt that secures the rotor to the hub assembly was removed with an impact screwdriver.

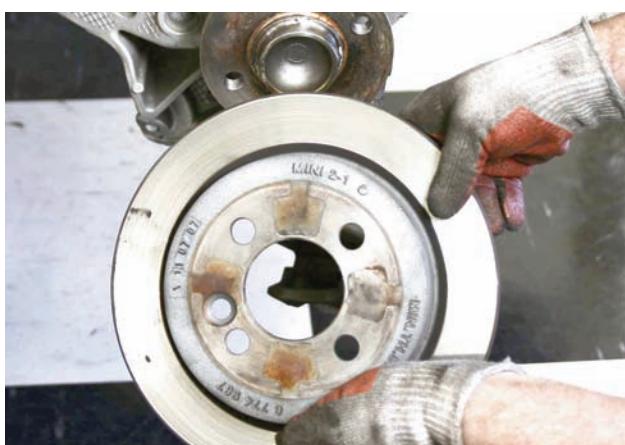
After the bolt was disconnected, the rotor was removed from the hub assembly. If the rotor sticks to the centering ring, a few taps with a rubber mallet will loosen the connection.

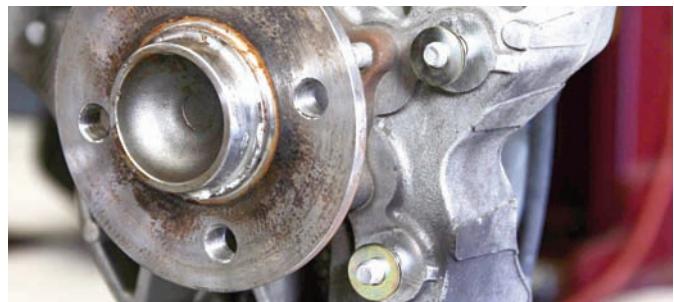
The caliper bracket bolts to the same location the original caliper bolted to. Here you can see the bolts in the holes and they will be used with a two shims per bolt.

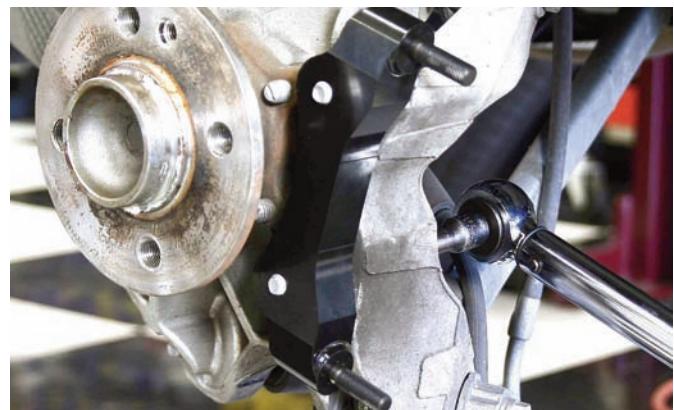
Here is the caliper bracket after the bolts were installed and tightened. The caliper to rotor centering was perfect before the final installation. After it was determined that the centering was perfect, the bolts were coated with Loctite 271 and they were tightened to 22 ft-lbs using a torque wrench.

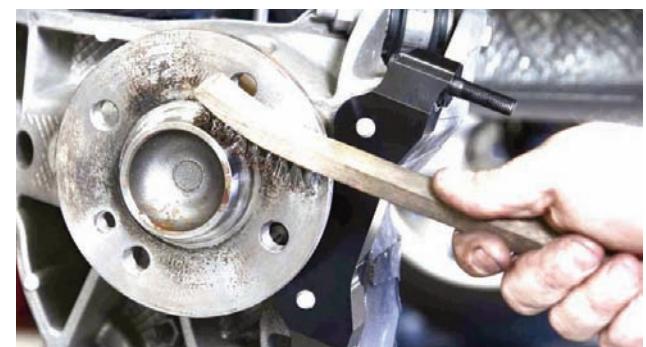
Grease, dirt or debris of any kind was removed from the face of the hub assembly, especially around the centering ring.

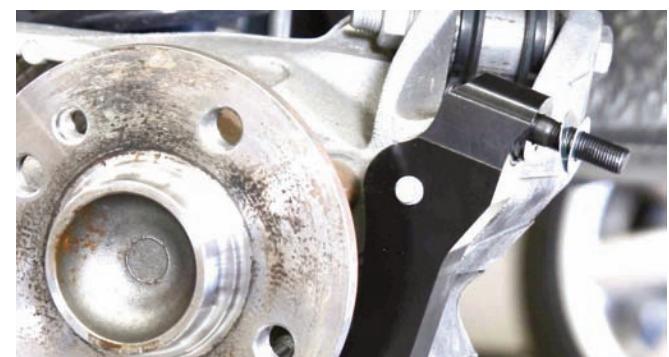
Before the caliper was installed, the bracket studs were loaded with two shims per stud.

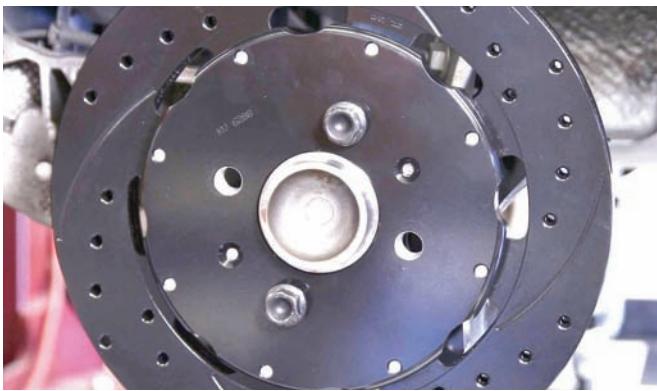
The rotor was placed on the hub assembly and then it was tightened with two lug bolts.

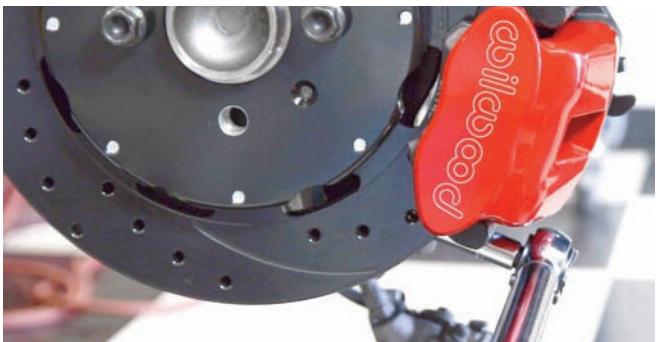
The caliper was attached to the bracket and then the caliper to rotor centering was examined. Adding or subtracting shims can be used for adjustments. After the rotor is centered in the caliper, the bolts were tightened to 30 ft-lbs using a torque wrench.

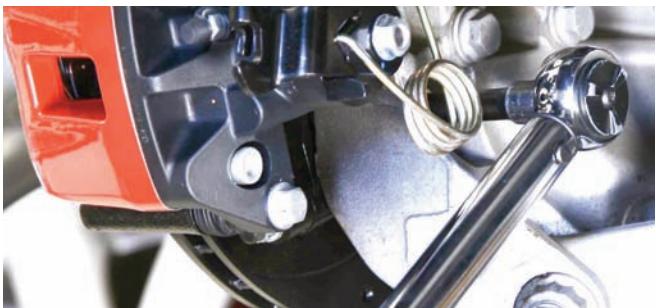
The bolts for the caliper mounting bracket were coated with Loctite 271 and then they were tightened to 22 ft-lbs.

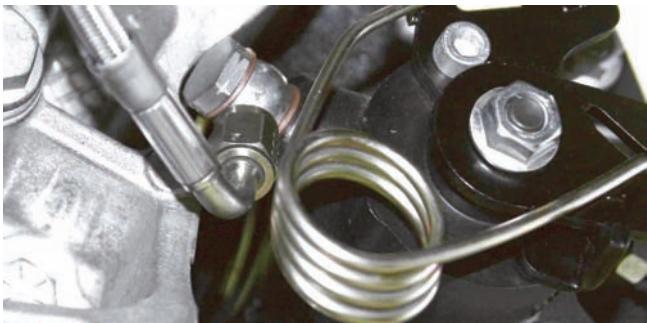
The protective rubber plug was removed from the caliper inlet. The banjo fitting was installed making sure there was Teflon tape on the banjo nut. The Wilwood part number 220-10879 was connected to the fitting and then the line was routed toward the steel line bracket.

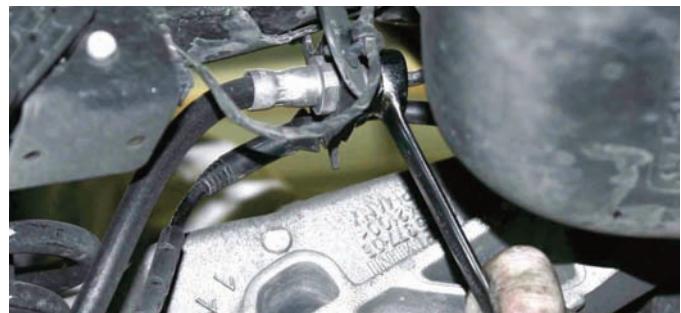
The line that was just connected to the caliper fitting was routed to this frame bracket. There is a special connection that adapts the braided line to the original steel line. The original flexible line was disconnected from the steel line first and then the bracket was modified for the new adapter fitting.

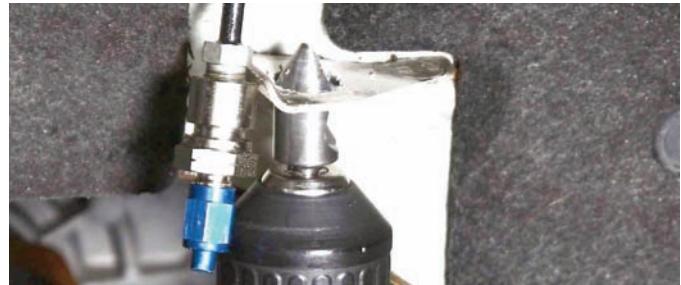
After the original line was removed the bracket was drilled out just a little so that the adapter fitting seen here can be installed in the bracket.

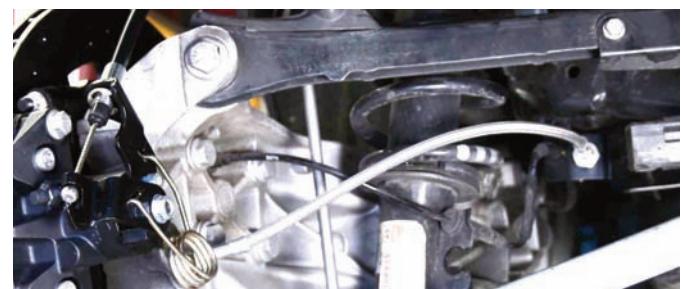
Here is the Wilwood part number 220-10879 braided steel Flexline running from the caliper to the bracket holding the steel line and adapter fitting. The line was routed away from any moving parts.

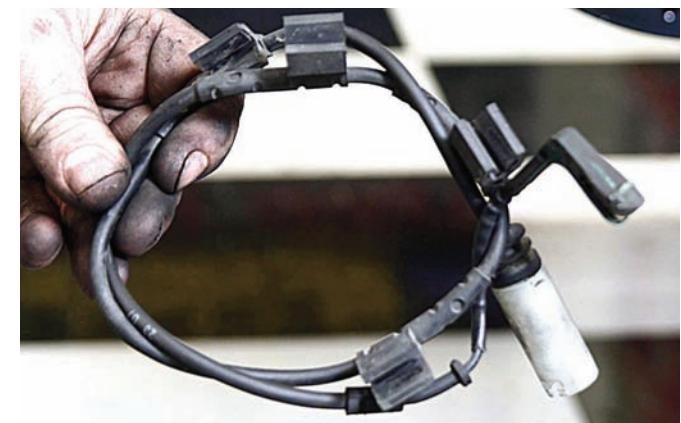
The brake wear sensor line was wrapped up and it can be installed in an inconspicuous place while connected in the car. If the brake sensor line is removed completely, the brake wear dash warning light will remain on.

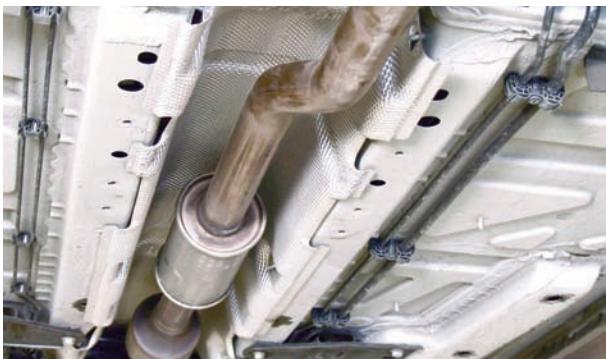
In order to complete the parking brake line routing, the bolts were removed from the second from rear heat shield and then it was removed.

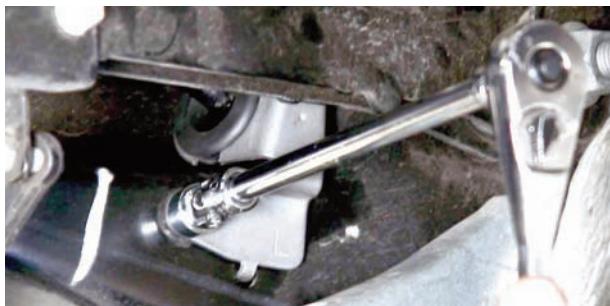
The bolts fastening the cable brackets on the rear suspension arms were also removed so they can be slightly modified.

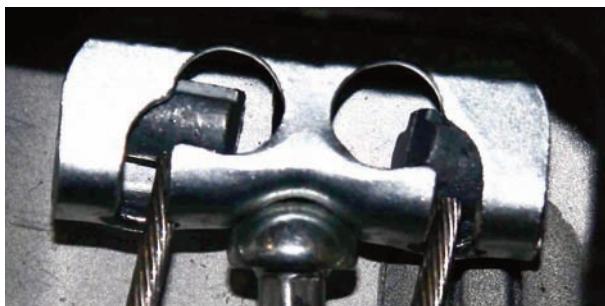
The console was removed to access the hand-brake cable equalizer with two cables going toward the rear. The two cables were removed from the equalizer and they were pushed toward the rear. The OEM cable end clips are hidden at the very rear of the tunnel and hidden under the rearward brace. Using a four-inch long metal tube, it was forcefully placed into each clip and then the cable was twisted and pulled out of the holes.

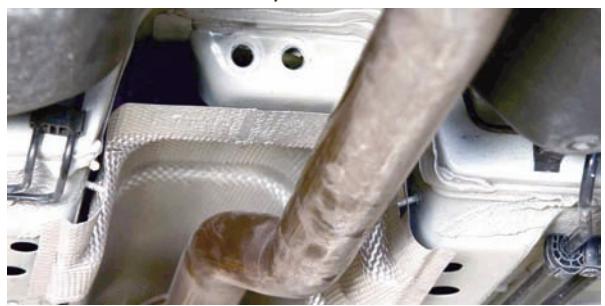
The two holes seen at the top of the photo were enlarged to 0.530-inch. The new cables were slid into the enlarged holes and were pressed into place in the equalizer.

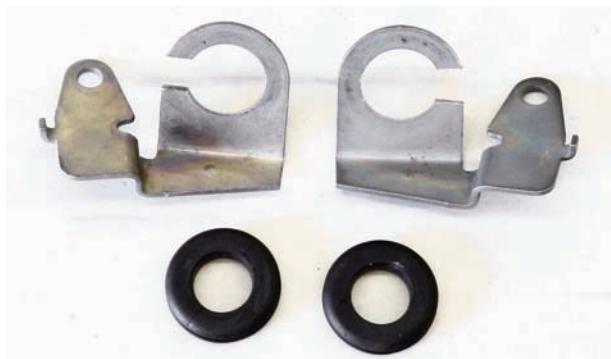
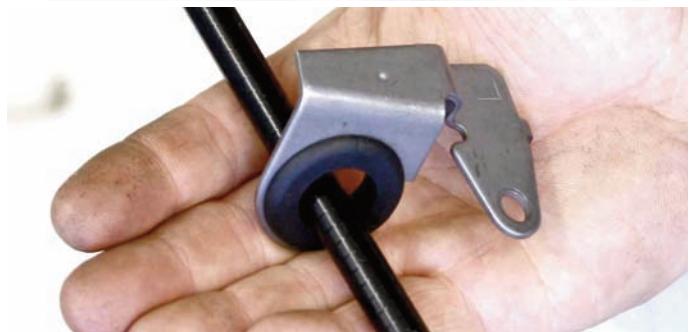
The mounting brackets that were previously removed were modified so the new lines could be run through. Using two grommets, they were placed over the line and were pressed into the small brackets as seen here. After the lines were in place, the small brackets were bolted back on the control arms.

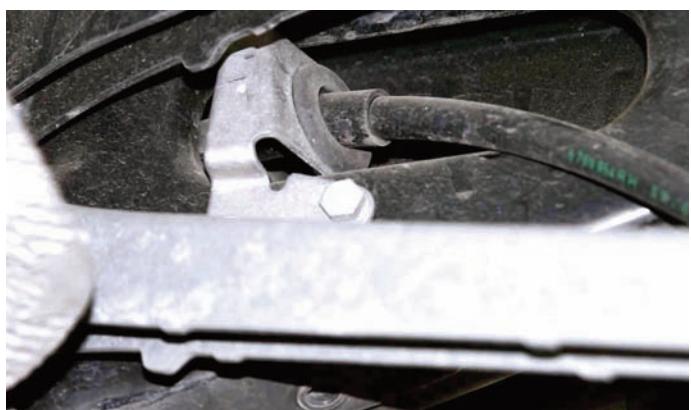
Here is the bracket after it was bolted in place. The brackets keep the parking brake lines safe and out of the way of any moving parts.

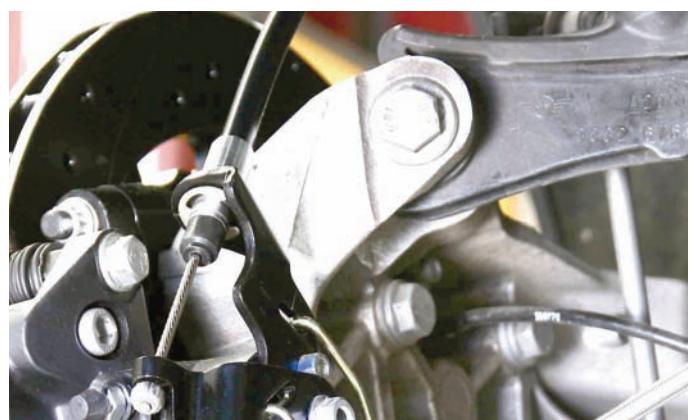
The lines were run forward and here is how they were attached to the master cylinder lever.

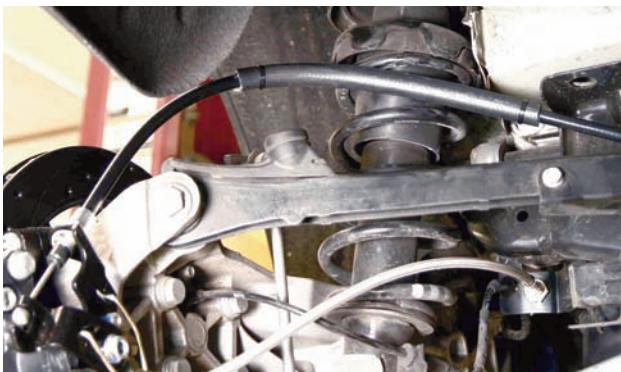
The parking brake line was wrapped with a rubber hose for added protection. It is secured to the line with a pair of black tie wraps.

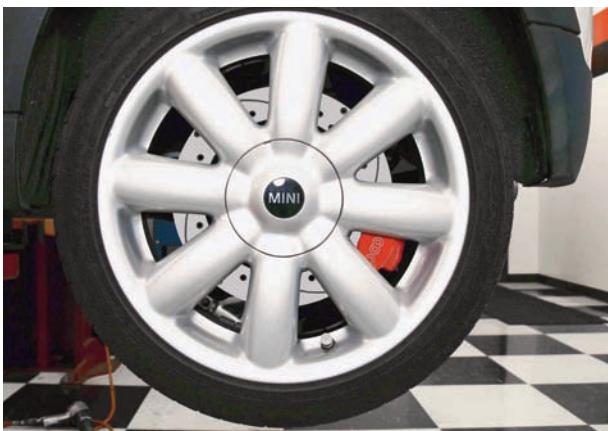
The wheel was installed and the Mini was ready to have the brakes bled followed by the brake bedding process. When that was finished, the Mini brakes were working terrific and they also look attractive behind the Mini wheel spokes
